NASA Technical Memorandum 86347

**DIRECT-STRIKE LIGHTNING PHOTOGRAPHS,
SWEPT-FLASH ATTACHMENT PATTERNS,
AND FLIGHT CONDITIONS FOR
STORM HAZARDS '82**

**Klaus P. Zaepfel,
Bruce D. Fisher,
and Merle S. Ott**

February 1985

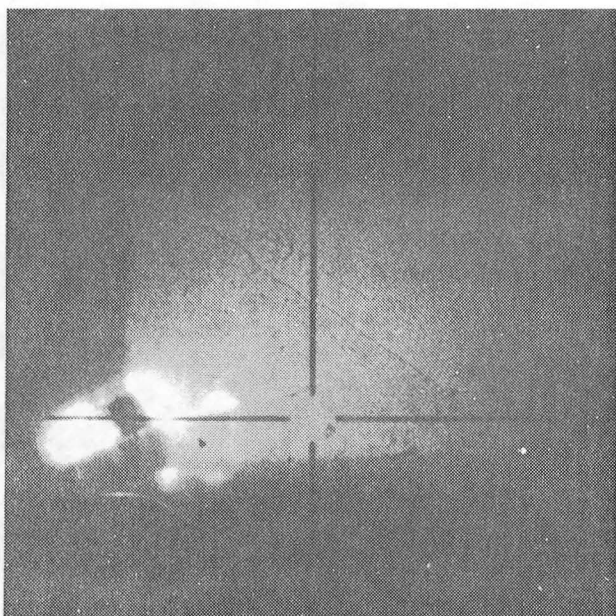
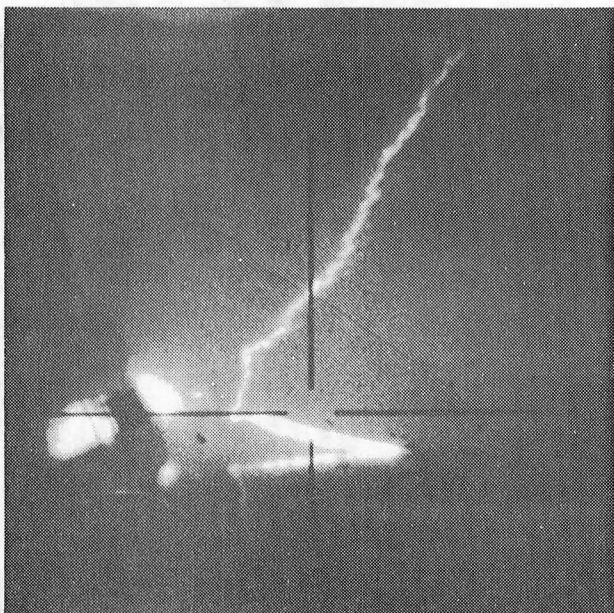
Figure 104. - Strike 74, Flight 82-038, aft camera.
